GAYPYRUS THE GREAT NECROPOSTER RETURNS

A Preservation Notice, Incident Report, Firmware Postmortem, Personal History, and Aggressively Overengineered Forum Reply

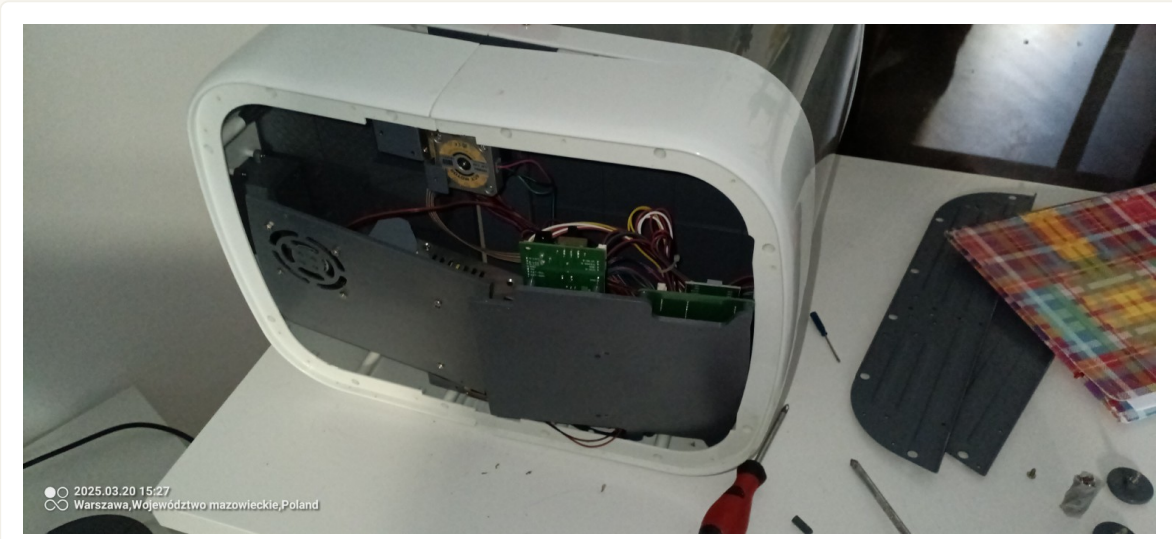
Figure 4.1.: **Exhibit A: first major disassembly.** Rear panel removed, metal electronics housing exposed. The patient is still recognizably a printer.

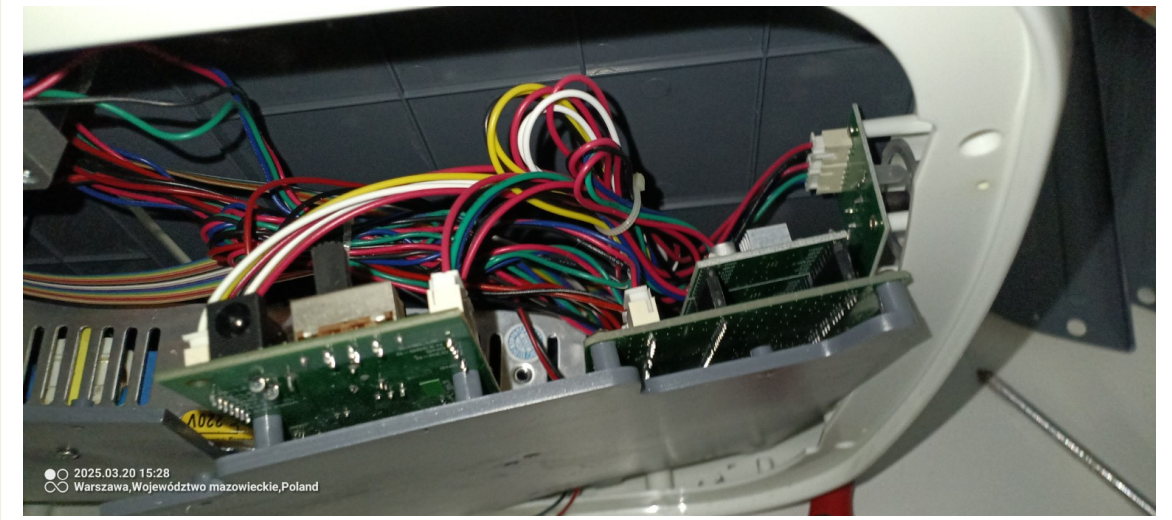
Figure 4.2.: **Exhibit B: electronics and wiring exposed.** The number of visible conductors has increased considerably. This is rarely emotionally reassuring.

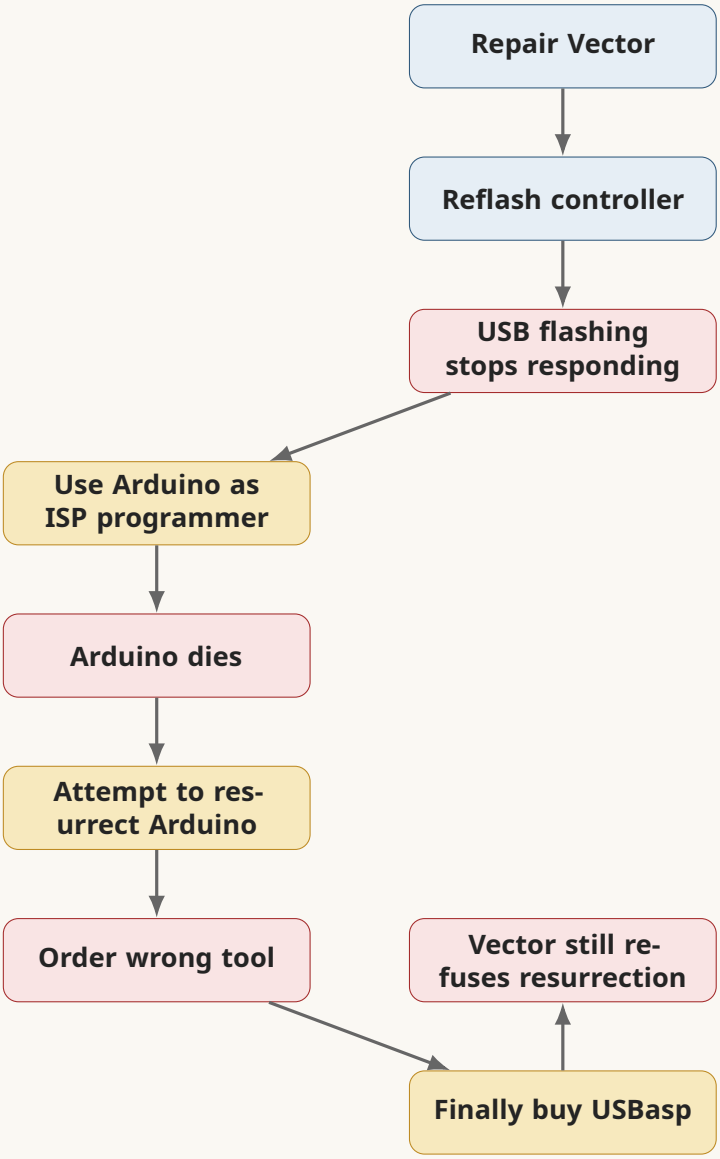
4.3.1. Repair Dependency Graph

The device I was using to resurrect the device I was trying to resurrect now itself required resurrection.

I had successfully reached the stage where I was **repairing the device I was using to repair the device I was trying to repair**. **NYEH HEH HEH.**, RECURSION.

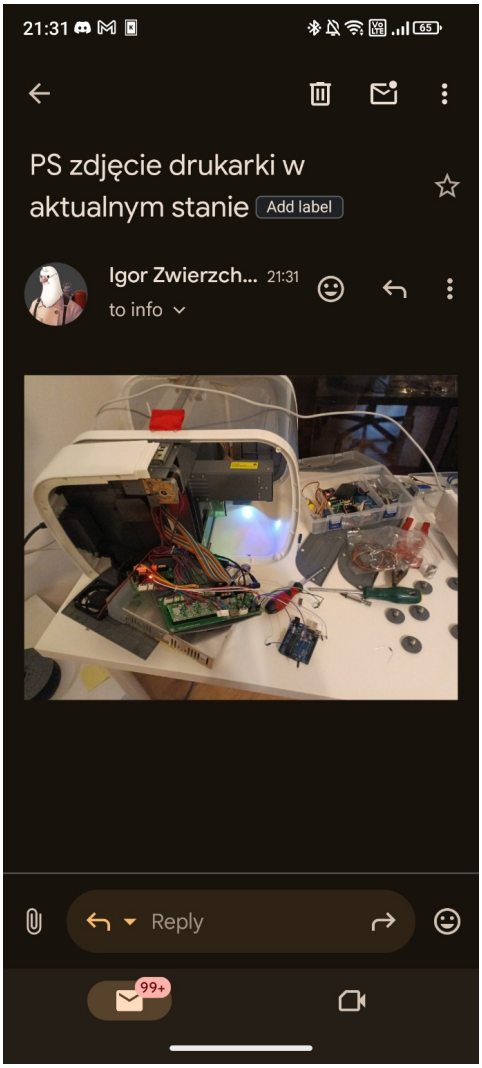
Figure 4.5.: **Exhibit E: the clarification email.** The embedded photograph shows the current state of the printer. This was apparently insufficient to inspire commercial enthusiasm.

The photograph showed the Vector with significant portions of its electronics removed from the chassis and spread across the table, wires everywhere, tools surrounding it, and an Arduino involved.

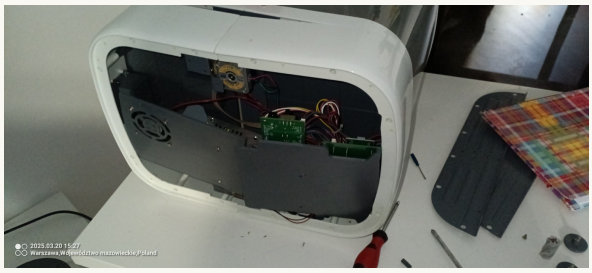
(a) Rear open / initial disassembly.

(b) Internal boards and wiring.

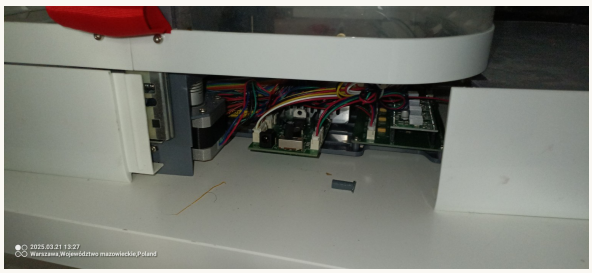
(c) Controller/electronics access.

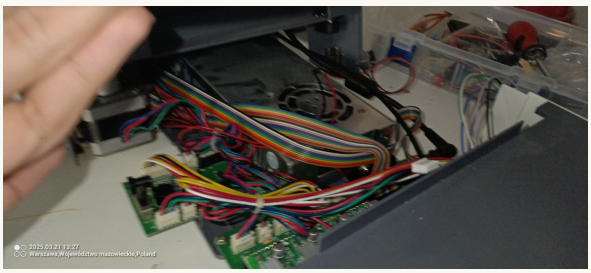
(d) Electronics removed during repair.

(e) Wide shot of the full autopsy.
